ALMO COLLEGIO BORROMEO PAVIA

Almo Collegio Borromeo: Restoration, Design, Retrofit, Technological and Systems refurbishment

DESCRIPTION OF PROJECT

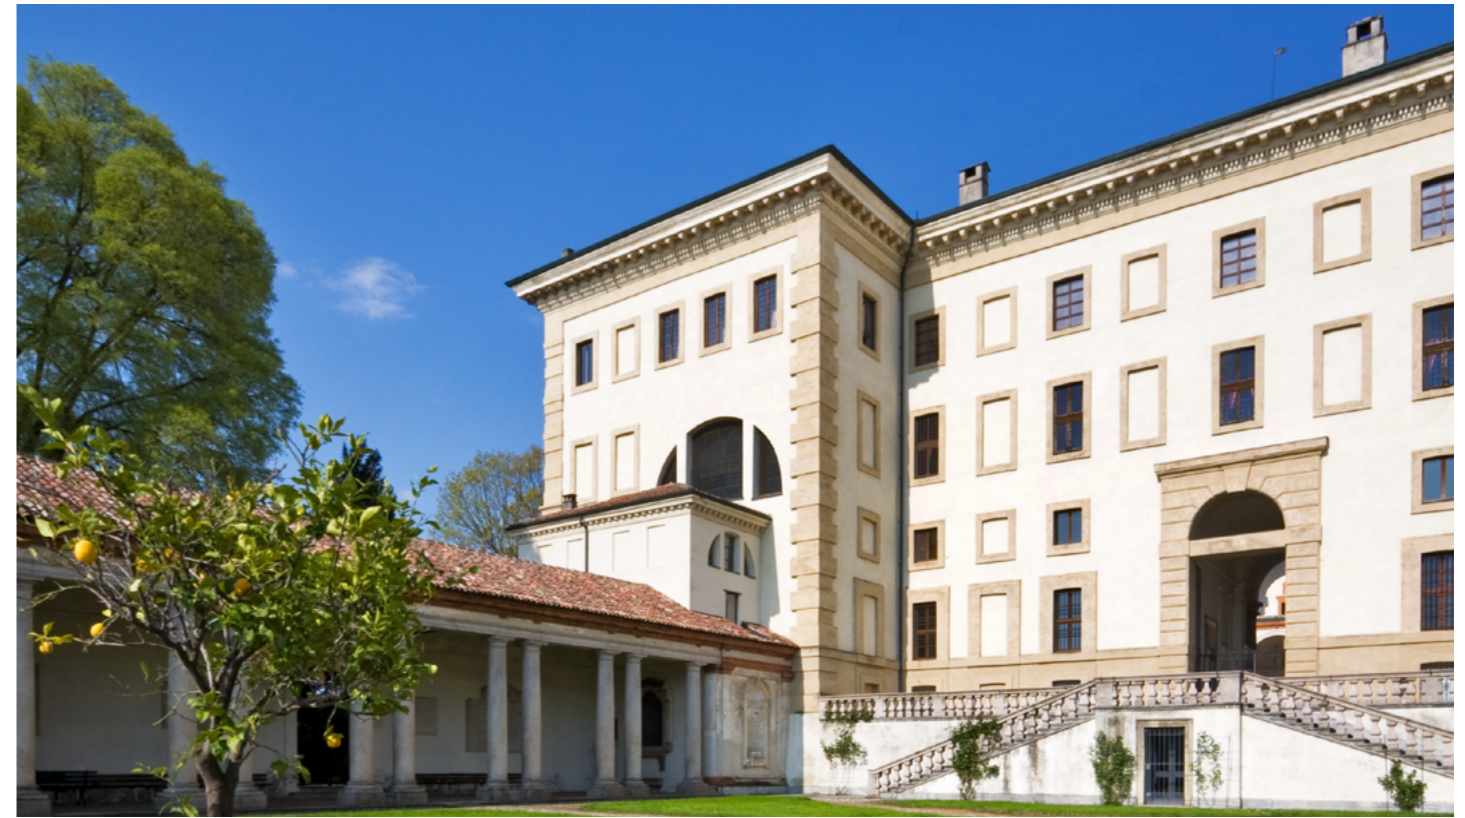
Above. View of the College from Piazza del Collegio Borromeo. Works on the external façade were concentrated on the preservation and restoration of the materials, trying to stop or reduce the process of degradation.

Works on the external façade were concentrated on the preservation and restoration of the materials, trying to stop or reduce the process of degradation. The façades of the internal courtyard have been subjected to a series of restoration works to conserve the finishing layers and to recover the original colors. Furthermore, some safety measures were taken to enhance the static behavior of some technological components.

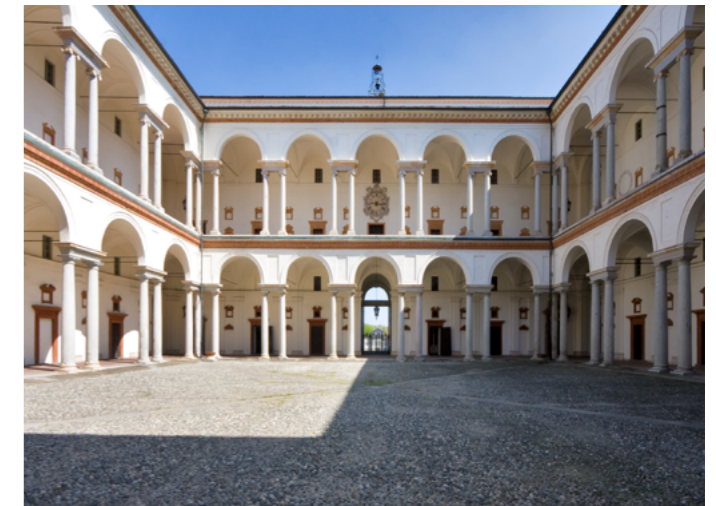
Right down. Replacement of the bases of the columns with a supports system in steel. The basements of the columns were really damaged and the level of degradation could have potential terrible consequences on the stability of the building.

Chemical and petrographic analysis were carried at the laboratory of the University of Pavia, while a campaign of ultrasonic and dynamic tests gave information about the modulus of elasticity and the density of the material contained inside the columns of the portico. The basements of the columns were really damaged and the level of degradation could have potential terrible consequences on the stability of the building. In some cases the footings of the columns needed to be completely replaced.
